SERVICE BULLETIN

SUBJECT: COMMUNICATIONS – ACARS & CPDLC – Modify unit software and update TSAP database.

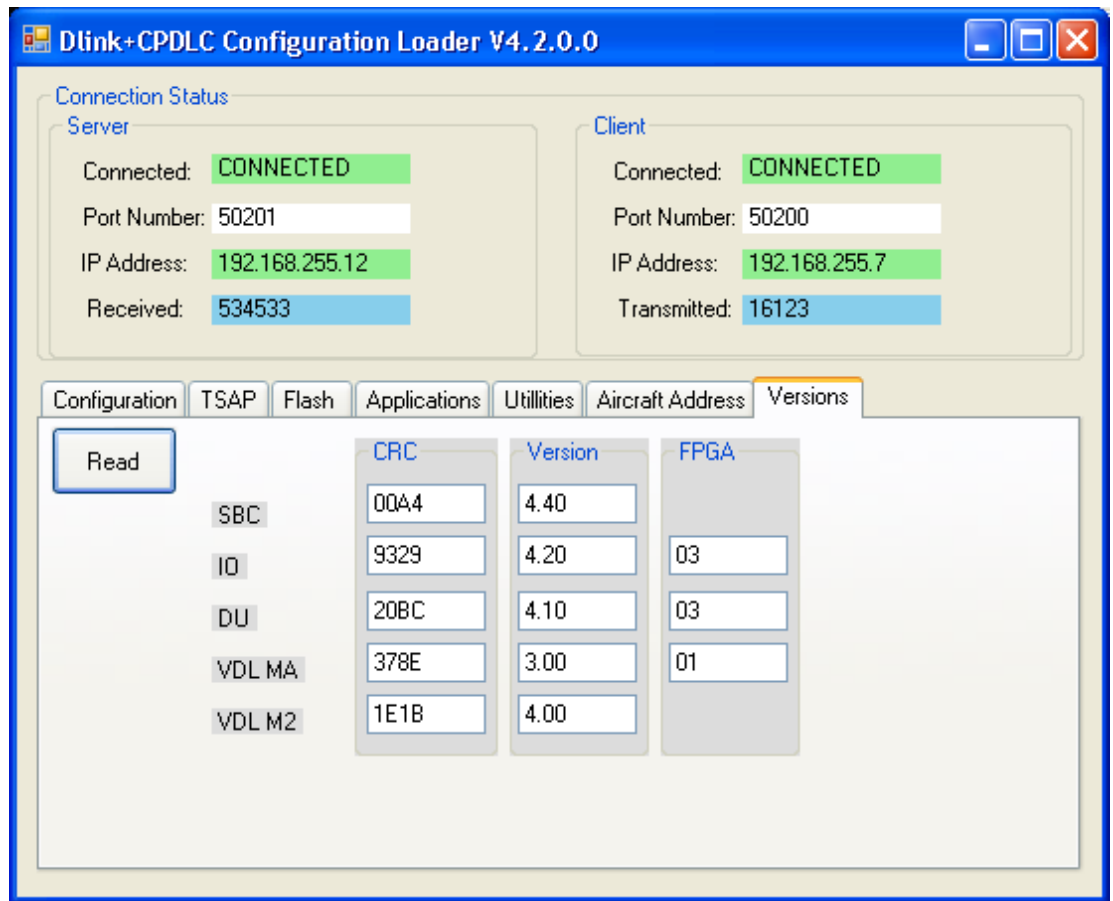
Picture 1

Note: The FAIL annunciator may turn on after the IO has been programmed, but will be off after all five files have been programmed
- (17) Go to the Versions tab of the Configuration loader and click Read. The programming has been successful if all numbers in the CRC, Version, and FPGA columns match **Picture 1**.

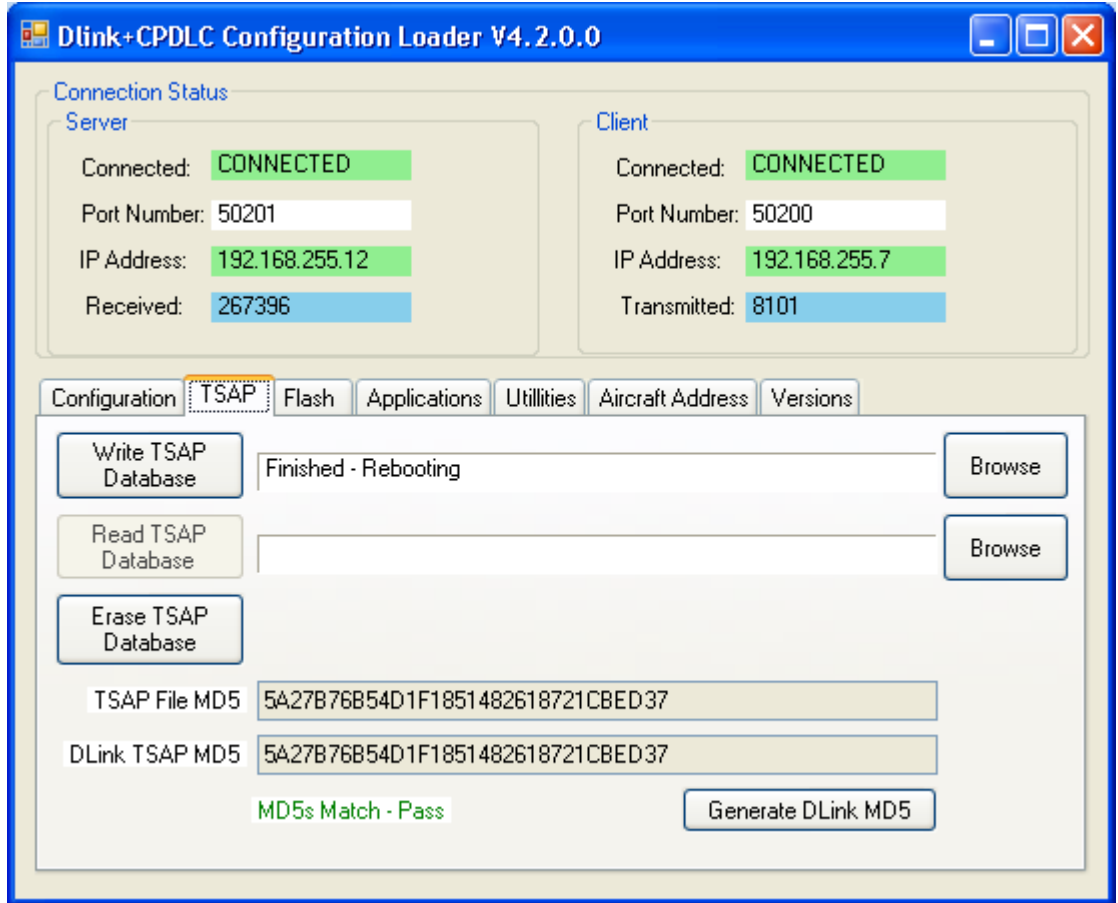
Picture 2

Click Generate DLink MD5. That button will be disabled and the Received field will increase while the calculations are made. After the received field has increased by approx. 260,000, a 32 digit number will appear in the DLink TSAP MD5 field. If the two MD5 fields match, a Pass message will appear beneath the two fields. A Fail message indicates the two fields do not match and must be corrected before proceeding. See **Picture 2**.

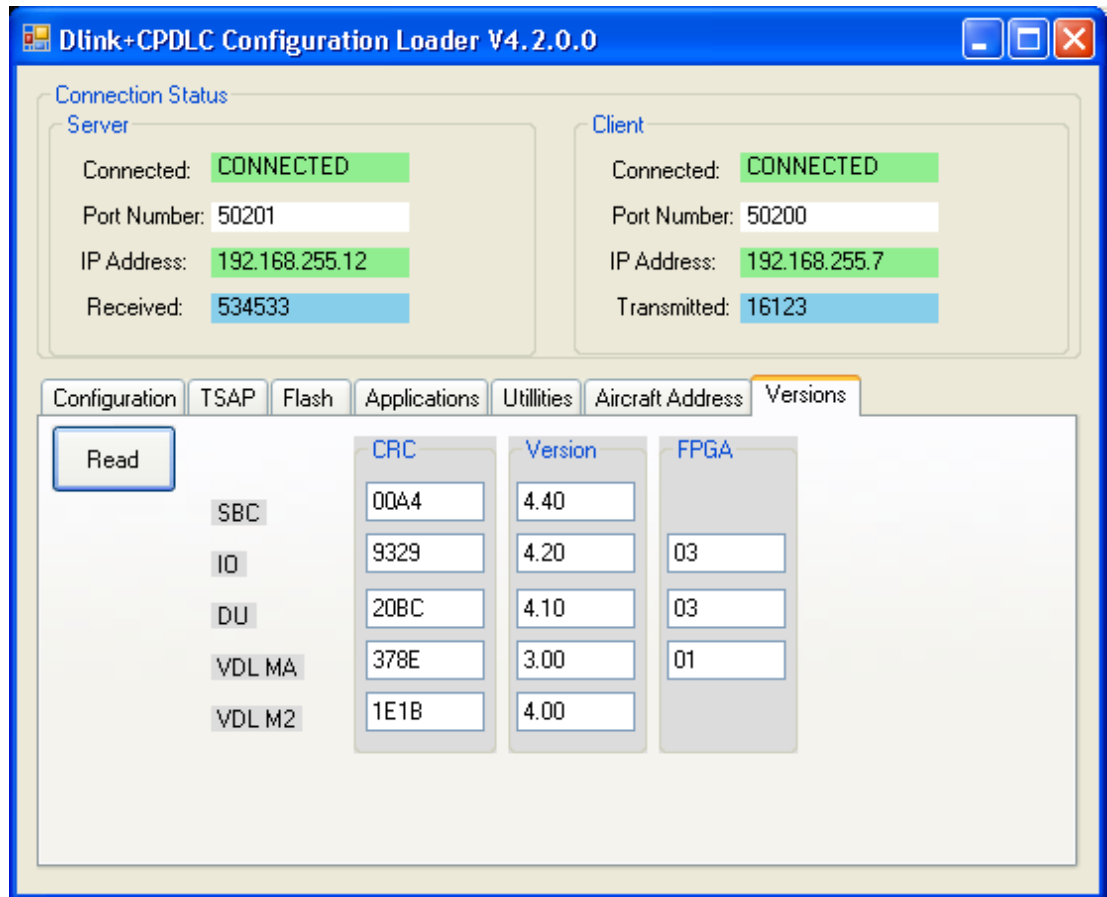
Picture 3

- Note:** The FAIL annunciator may turn on after the IO has been programmed, but should be off after all five files have been programmed.
- (17) Go to the Versions tab of the Configuration loader and click Read. The programming has been successful if all numbers in the CRC, Version, and FPGA columns match **Picture 3**.

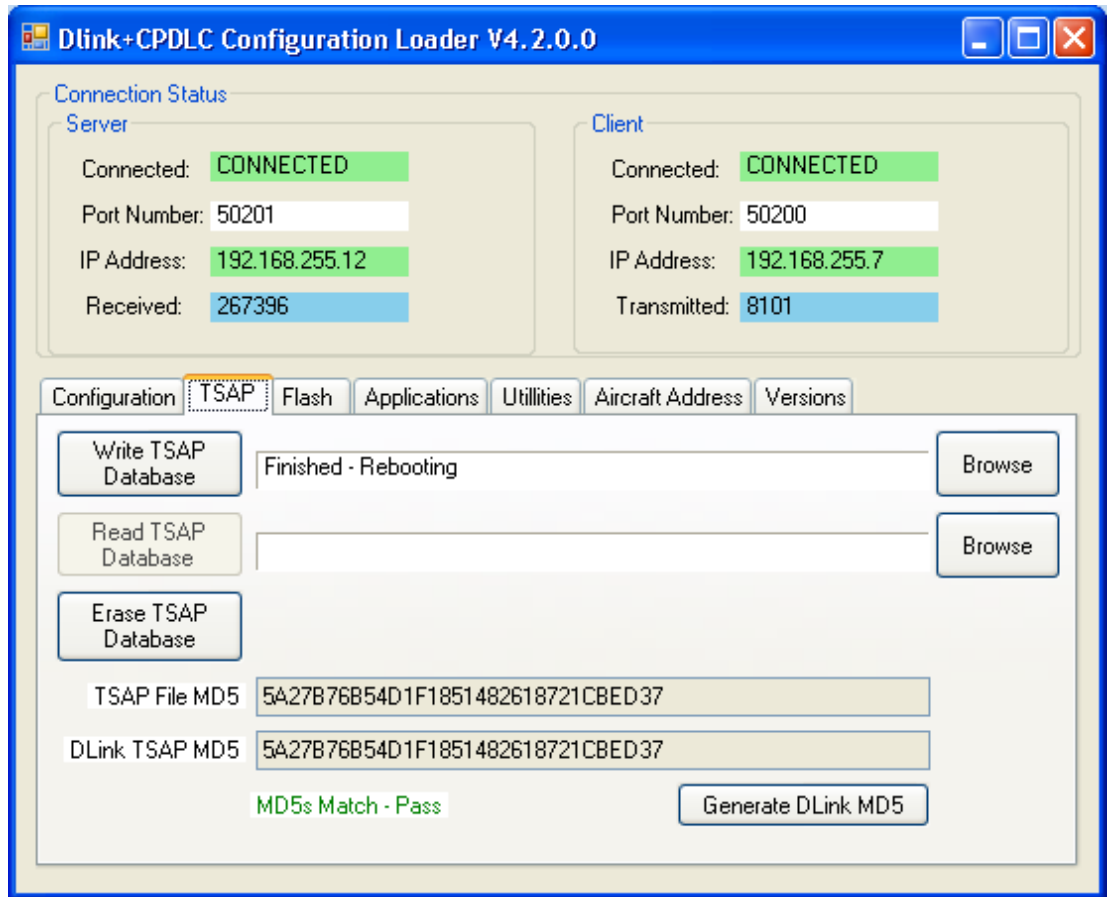
Picture 4

Click Generate Dlink MD5. That button will be disabled and the Received field will increase while the calculations are made. After the received field has increased by approx. 260,000, a 32 digit number will appear in the Dlink TSAP MD5 field. If the two MD5 fields match, a Pass message will appear beneath the two fields. If they do not match, a Fail message will appear. See **Picture 4**.
