SERVICE BULLETIN

SUBJECT: COMMUNICATIONS – ACARS & CPDLC – Modify unit software (Mod 4).

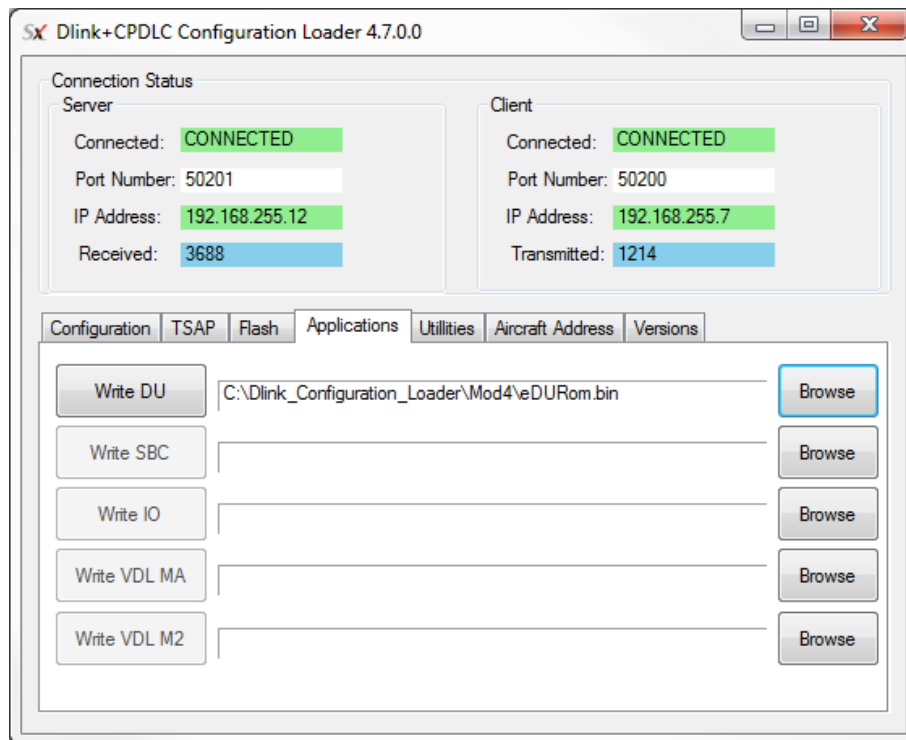
Figure 1 – Applications Tab

- (1) Attach Ethernet cable between PC and aircraft maintenance port of Dlink+.
- (2) Double click the application “Dlink_Configuration_Loader.exe”.
- (3) Enable power to Dlink+. Wait until the status reported by the Dlink_Configuration_Loader.exe changes from NOT CONNECTED to CONNECTED in both the server and client areas.
- (4) Go to the Applications tab of the Dlink_Configuration_Loader.exe. (see Figure 1)

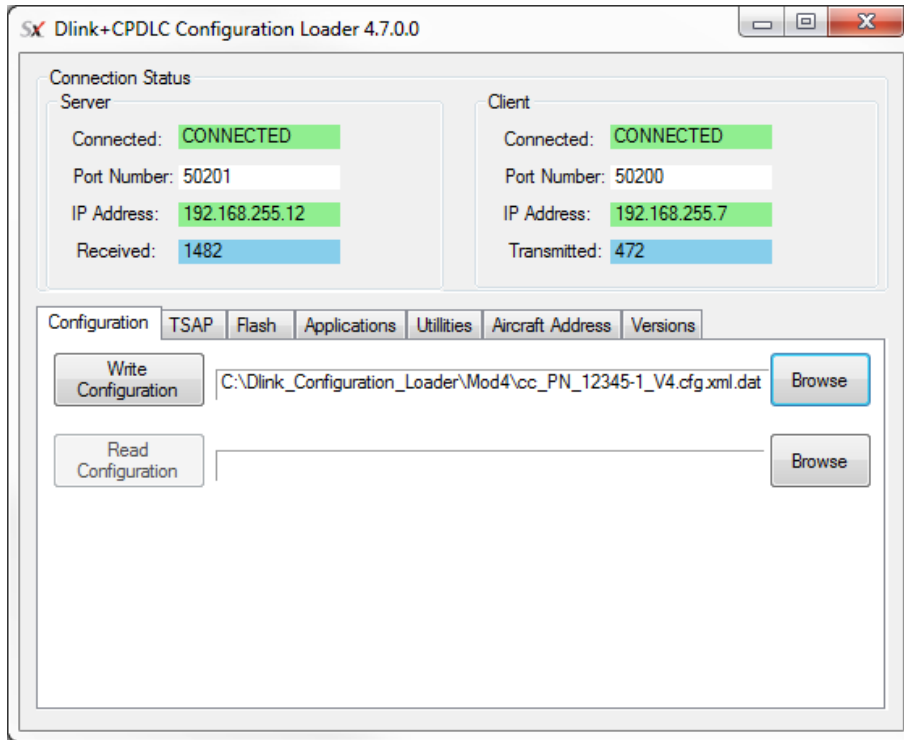
Figure 2 – Configuration Tab

- (8) Go to the Configuration tab of the Dlink_Configuration_Loader.exe. (see Figure 2) Click Browse on the Write Configuration Line and navigate to C:\Dlink_Configuration_Loader\Mod4. Open the customer Mod 4 configuration for your airline and this aircraft. Click Write Configuration.

The Dlink_Configuration_Loader screen will count up while RECEIVING CFG and then the Dlink+ will show "DLINK IS WRITING TO PM". Wait until the unit reboots and connection status becomes CONNECTED. The CORRUPTED OR MISSING CONFIGURATION message should not be present.

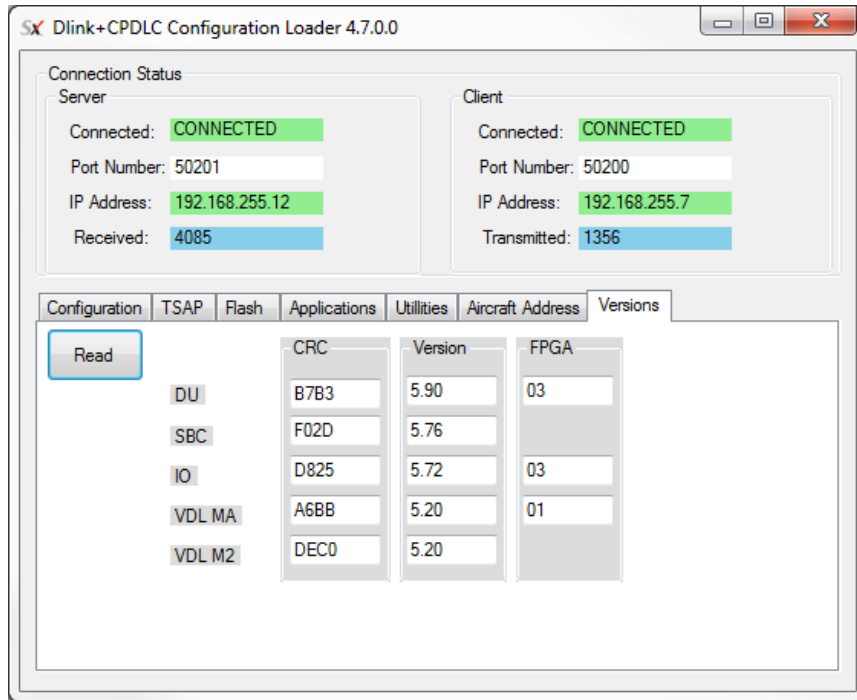
Figure 3 – Versions Tab

- (10) Go to the Versions tab of the Configuration loader and click Read. The programming has been successful if all numbers in the CRC, Version, and FPGA columns match Figure 3.

- (1) Disable power to the Dlink+.
- (2) Remove Ethernet cable connecting PC to unit being programmed.
- (3) Enable power to the Dlink+ and wait until bootup is complete.
- (4) Press USER key, then MAINT LSK (line select key), then CONFIG LSK, then VERSIONS LSK.
- (5) Confirm that the display shows HW: 14494-1-XX BOM REV B and that CRC and FPGA values agree with Figure 1.

VDL MA in Figure 1 is equivalent to M0 on the unit.

- (6) Press down arrow LSK (right of display).
- (7) Confirm that CFG PART NO agrees with part number included in filename of correct configuration file for aircraft.
- (8) Press down arrow LSK (right of display).
- (9) Confirm that Version values agree with Figure 3 – Versions Tab.
- (10) Press USER key, MAINT LSK, CONFIG LSK, USER EDIT LSK. Enter using Dlink+ keyboard, "USER00". Press ENTER key (not RETURN).
- (11) Confirm AC TYPE is the expected model, CUSTOMER is correct, and VERSION matches the v number included in the filename of the correct configuration file for the aircraft.
- (12) If the unit passes the test, proceed to D. Return to Service.

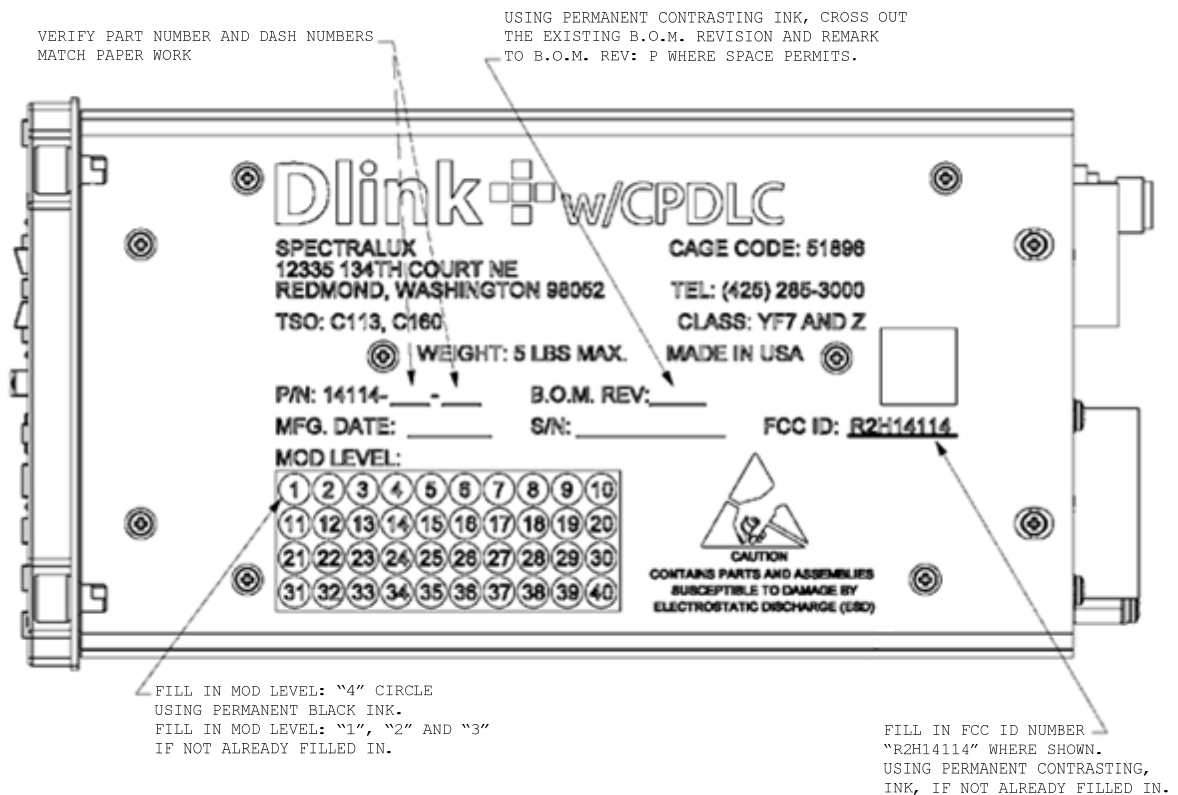
Figure 4 – Mod 4 Label Marking

- (1) Mark the unit label according to Figure 4 – Mod 4 Label Marking.
- (2) Perform SB – 14114-23-08 or later service bulletin updating the TSAP database, if not done already on this unit.
